The Design and Operation of a Picket Weir to Sample Brook Trout and Landlocked Salmon in Tributaries to Moosehead Lake

Progress Report No. 1

July 2018
Maine Department of
Inland Fisheries & Wildlife
Fisheries and Hatcheries Division

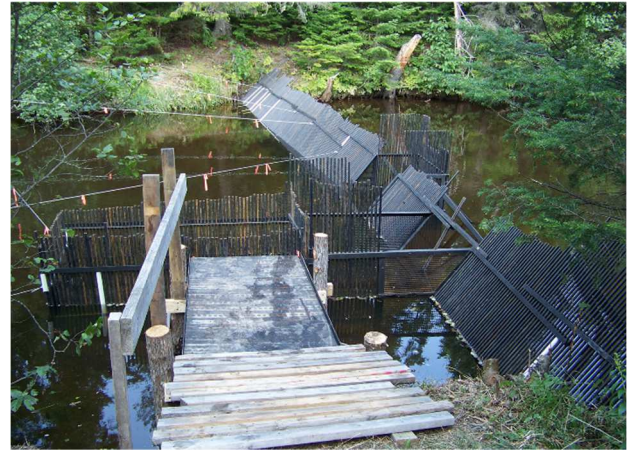
Figure 2. The finished Socatean Stream weir in 2009.

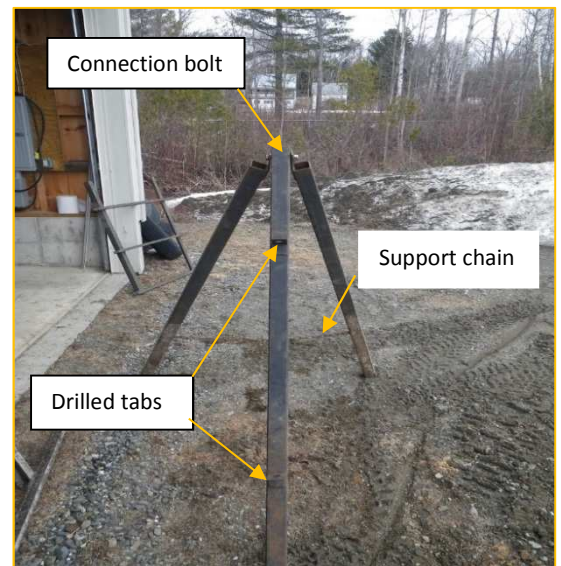
Fourteen tripods were constructed of 6 ft x 2½ in square steel tubing. They were designed so the two back legs are situated downstream to anchor and support the weir as flow pushes against it. The single front leg faces upstream and the blocking panels tie into and rest against it. The two back legs of the tripod have a 2 in x 5 in x ¼ in tab welded on the top of each. The tabs are bent at approximately 30 degree angles and have a ¾ in hole through the center. The ends of a three-foot piece of ¼ in chain are welded 18 in from the bottom of each back leg. The chain prevents the back legs from spreading when subjected to pressure resulting from water pushing against the blocking panels. The front leg of the tripod has a ¾ in hole drilled through it, 1 in from the top. A 4 in x 5/8 in grade 8 bolt is used to connect the three legs at the top by running it through the two tabs of the back legs and the hole in the top of the center leg. The front leg contains two tabs made of 3 in x 2 in x 3/16 in angled steel. Tabs are cut 2 in long, and have two ears measuring 3 in x 2 in and 2 in x 2 in. The 3 in x 2 in ear has a 1 in hole drilled in the center of it. Two tabs are placed on the leading edge of the front leg 18 in from the top and bottom of the front leg such that the 2 in x 2 in ear is welded to the leg with the 3 in x 2 in tab facing up (Figure 4).

Figure 4. Tripod for supporting the blocking panels.

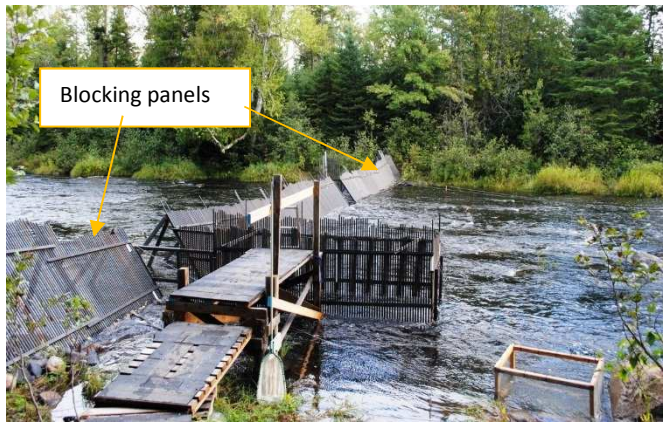
The blocking panels are the large panels which span the stream and extend from each side of the entrance of the collection box to the shore on either side. Blocking panels are supported at each end

Figure 5. View of blocking panels spanning the stream.

by a tripod or anchored into the streambank. These panels prohibit fish movement upstream or downstream of the weir site. The blocking panels consist of 6 ft x 3 in x $\frac{1}{4}$ in channeled steel, with 1 in holes that start $\frac{1}{4}$ in from the end and spaced $\frac{1}{2}$ in apart and run lengthwise down the center of the piece of steel. There are 8 holes per linear foot of channeled steel. Each section of the blocking panel contains two pieces of the

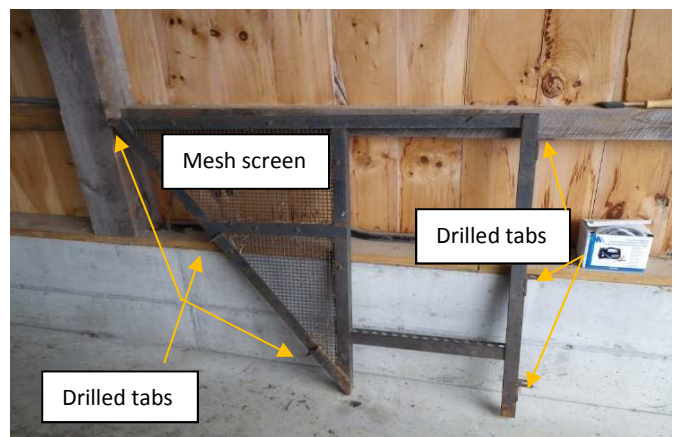
The entrance panels are the heaviest pieces of the weir, weighing approximately 80 lbs. There are two sets of entrance panels used on the weir. One set is used when collecting fish moving upstream and the other for collecting fish moving downstream. The only difference between the two sets is the leading angle of the panel where it attaches to the blocking panels. The set used on the upstream collection box is angled at 55 degrees forward at the top and the set used on the downstream collection box is angled 55 degrees backward at the bottom. The exterior frame is constructed of 2 in x 2 in angled steel. The front portion of the panel is triangular shaped and is comprised of a $\frac{1}{2}$ in square, 3 mm wire mesh-screen measuring 4 ft high by 3 ft long and 5 ft on the angled side. The screen is held in place with a 2 in x 2 in exterior frame and a 1 in x 1 in interior frame both $\frac{3}{16}$ in thick, and drilled with $\frac{1}{4}$ in

Figure 6. Left frame of the upstream entrance panel.

holes and bolted together. Two - 20 in x 2 in x 3/16 in pieces of flat steel are welded to the outer edge of the angled portion of the frame on either side of the mesh screen for added support. The back 2 ft portion of the angled steel frame is drilled with 1 in holes and spaced ½ in apart. These holes accept the 5 ft long, ½ in pipe with an outside diameter of 0.84 in to close in this portion of the frame. The panels have three - 2 in x 2 in tabs drilled with a 1 in hole in the center and are evenly spaced from top to bottom and are welded to the side of the angled portion of the screened frame. The end pipe from the blocking panel is passed through these two tabs tying the two panels together. There are three similar tabs on the back leg of each entrance panel that tie into each side of the front panel and the three side rails on either side of the collection box by a single 6 ft pipe (Figure 6).

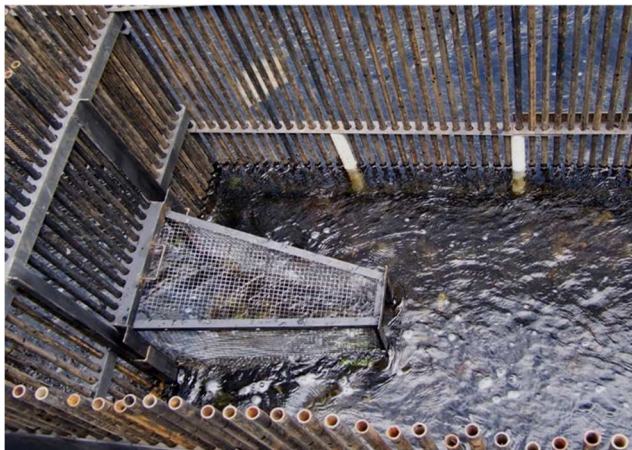
The fyke is used to funnel fish from the entrance into the collection box (Figure 7). The small end is located inside the collection box and is approximately 12 in off the bottom of the stream bed, making it difficult for fish to find the opening to escape. The initial fyke consisted of a wooden frame covered

Figure 7. Top view of the fyke inside the collection box.

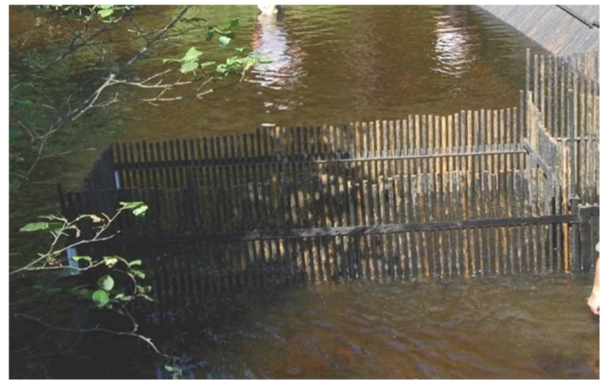
The collection box is the part of the weir that holds the fish (Figures 7 and 8). Studies designed to collect fish moving into and dropping out of a stream require two collection setups. Each collection box is comprised of a front panel, a back panel, and two side panels made of six (3 per side) 8 ft x 2 in x 2 in angled steel. The front and back panels are welded rigid frames (Figures 9 and 10).

Figure 8. Outside view of the collection box.

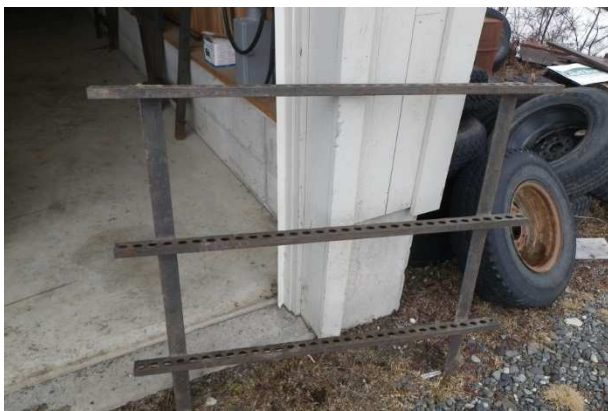
The back panel has two - 4 ft x 2 in x 2 in upright pieces of angled steel (undrilled) that have three - 4 ft x 2 in x 2 in angled steel (drilled). Similar to the 6 ft channel pieces of the blocking panels, all pieces receiving pipes are drilled with 1 in holes spaced $\frac{1}{2}$ in apart and run lengthwise down the center of the angled steel.

Figure 10. View of the back panel of the collection box.

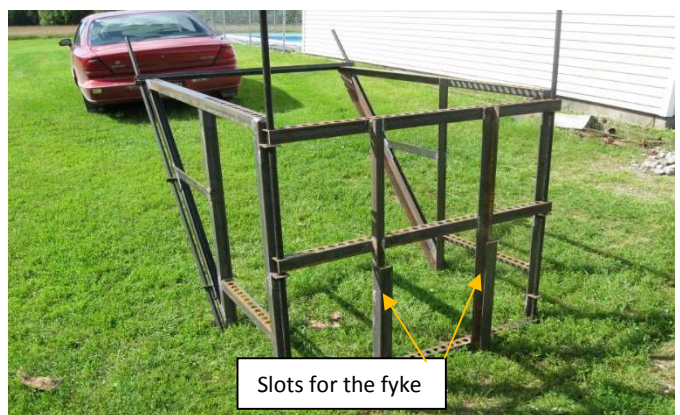
The front panel is constructed of two - 4 ft x 2 in x 1 in upright pieces of angled steel spaced 24 in apart and each has a 2 ft x 2 in x 2 in piece of angled steel welded onto the side of them at the bottom to form a slot or track which the fyke slides securely into. There are three - 4 ft x 2 in x 2 in cross pieces of angled steel with

Figure 9. View of the front panel frame of the collection box connected to the two side entrance panel frames.

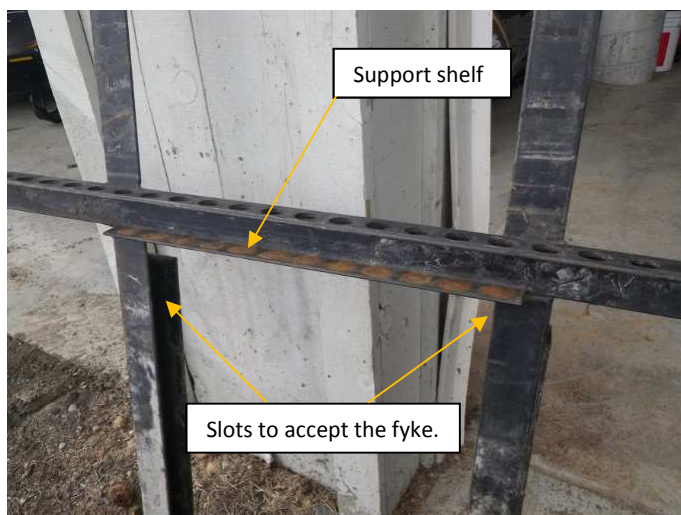
of the fyke to form a suspended panel above the fyke (Figure 11). A piece of plywood is typically placed over the top of the collection box to keep birds and other predators from entering the box.

Figure 11. View of shelf for the short pipes and slots for the fyke to slide into on the front panel of the collection box.

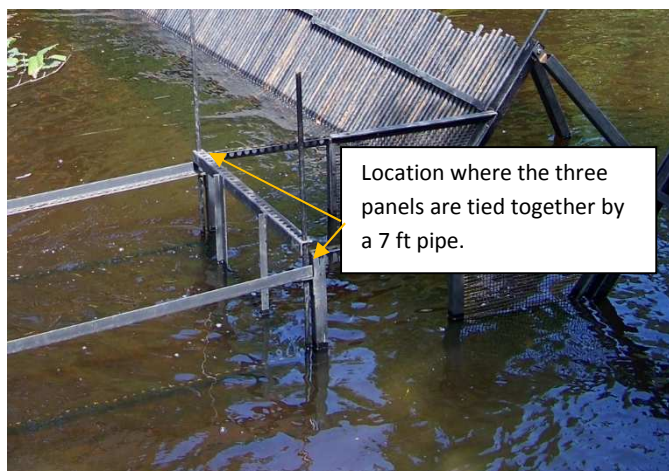
Figure 16. View of the entrance panels, front panel of the collection box and drilled angled steel, tied together by 7 ft pipes.

The three tabs on the backs of the left and right entrance panels, the ends of the front panel to the collection box, and the six drilled pieces of angled steel that form the sides of the collection box were tied together by inserting a 7 ft pipe through the intersection of all three components (Figure 15). The back panel of the collection box was then tied to the other ends of the six pieces of drilled angled steel by inserting a 7 ft pipe on either side of the back panel. One tripod was placed on the outside edge of each entrance panel for stability

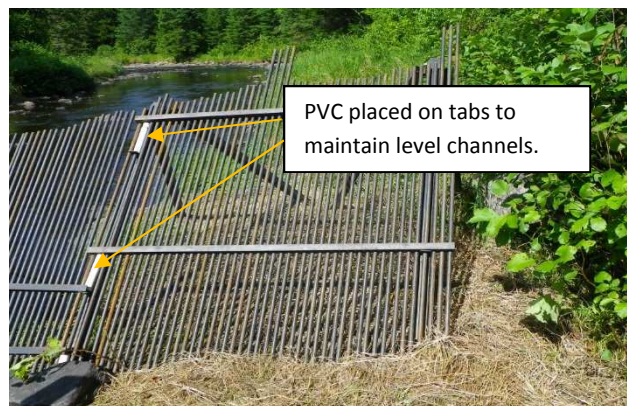
the tabs of the front legs on the tripods and tied together using 7 ft pieces of pipe. Some overlap of the 6 ft channeled steel occurred. Close attention was needed to assure that we maintained the same number of open holes on the top and bottom pieces of channeled steel between the pipes tying the front legs of the tripods. We noted that if the number of open holes on top and bottom differed, then the pipes will not line up correctly and openings larger than $\frac{1}{2}$ in will result potentially allowing fish to pass through the weir. When uneven pipes were encountered, the pipes were pulled out and the channeled steel was realigned so there were the same number of open holes on the top and bottom

Figure 15. Use of PVC sections, resting on tab of front tripod leg to maintain level channels in the blocking panel when moving up the streambank.

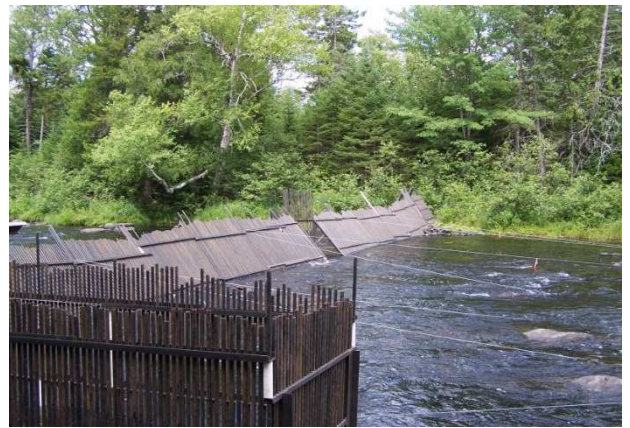
Once the weir was completed we used $\frac{1}{4}$ in to $\frac{3}{8}$ in cables to help support the structure during high flow events. The number of cables we used varied from site to site, and was based on the width of the stream and the potential flows that could occur during high water events. Typically, one was placed on each end of the weir, one on each corner of the upstream portion of the collection box, and others were evenly spaced across the weir to help support the weight of debris and the force of the water against the weir (Figure 17). The cable was attached to the upstream leg of a tripod by wrapping it around and securing it with a cable clamp. The other end of the cable was then fastened to something stationary, such as a tree or boulder, upstream of the weir. Small loops were placed in the cable using cable clamps, and then a come-a-long was used to tighten and secure the cable back onto itself with additional cable clamps.

Figure 17. View of support cables connected to the weir panels and upstream portion of the collection box.

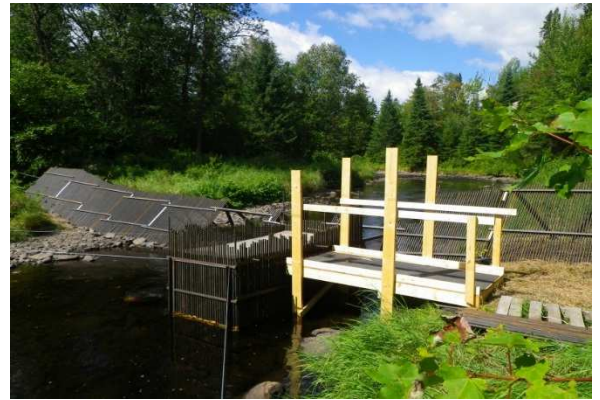
The platform was then leveled from the bank to the collection box then attached to six posts positioned upright on the bottom of the stream and cross-braced for support. The six posts should be long enough to extend above the platform and wooden 2 x 4 rails attached between them on either side, approximately 36 in above the platform to create a rail for safety (Figure 18). A ladder was lowered from the work platform into the collection box to gain access. On one occasion a ladder was positioned against the outside of the collection box to enter the collection box when a walkway could not be constructed.

Figure 18. Walkway/work platform extending from the streambank to the collection box.

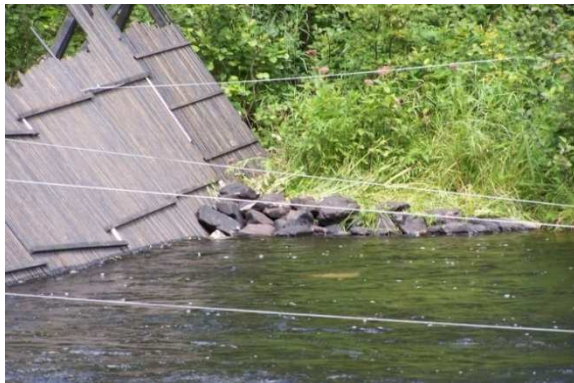
Rocks were placed along the upstream ends of the blocking panels where they tied into the stream banks to help the overall performance of the structure and assure that fish didn't circumvent the weir.

Figure 19. Rip-rap material piled along the streambank to reduce potential erosion during high flow events.

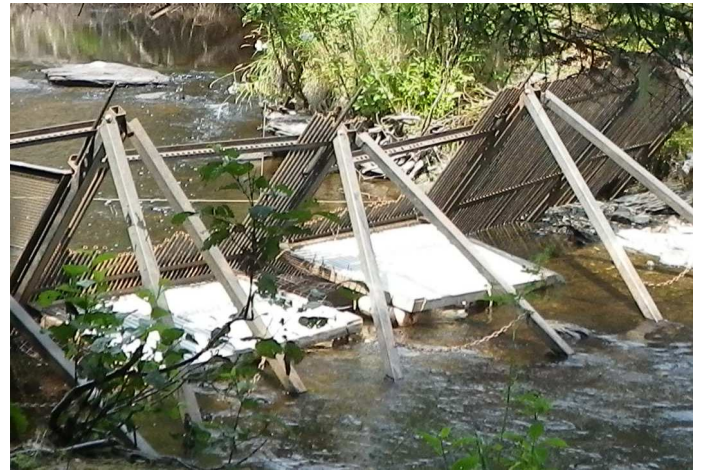
We developed drop-down panels to help reduce the damming effect created by the leaves/debris on the blocking panels. These drop-down panels were designed to act as automatic relief valves during high flows. The openings created by these panels allowed water and debris to pass through the weir, thus reducing the amount of pressure behind it (Figure 20). The panels are 3 ft x 4 ft and the frame is built from 2 in x 3 in lumber. A 3 ft x 1 in x 1 in piece is fastened in the center of the frame for stability. On the 3 ft sides, 1 in holes were recessed 1 in by drilling into the wood and spaced $\frac{1}{2}$ in apart. PVC conduit was cut to the appropriate length to insure a snug fit into the frame to create a panel with similar bar spacing as the blocking panels. For flotation, three bullet-style buoys were attached to the top of the panel and the PVC conduit was filled with

Figure 20. Drop-down panels installed in the weir. Note the shorter pipes at the bottom of the large opening.

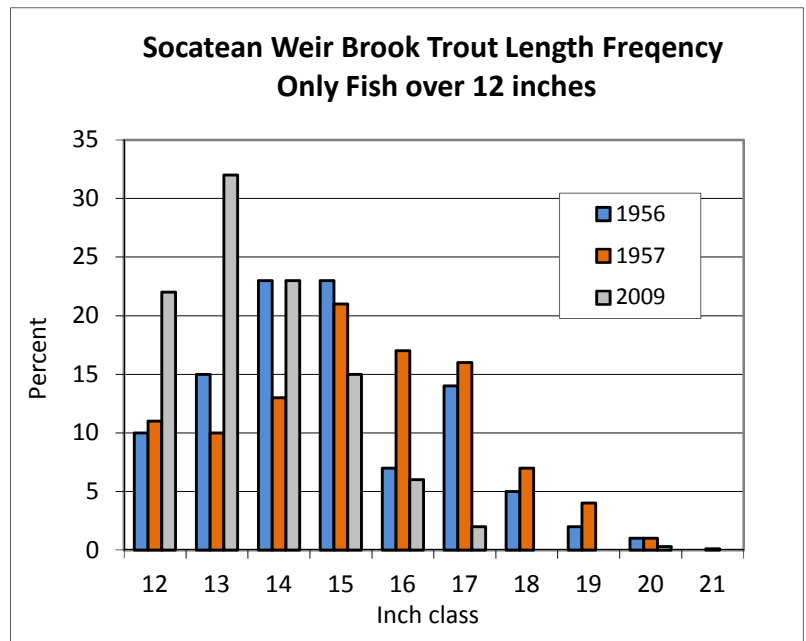
Figure 233. Brook Trout length frequency comparison from Socatean Stream.

very small fish. The current weir has a spacing of 1/2 in. In the 1950s, fish were captured down to 4 in in

length while the smallest trout captured in 2009 was 9.1 in. In 2009, we captured 370 trout of all sizes in Socatean Stream. Several washouts occurred from heavy rain events; therefore, we did not capture the entire run of spawning fish. We can compare catches of trout exceeding 12 in to eliminate any bias in the differences in the weir gap and to focus on mature trout moving upstream from Moosehead Lake. AuClair took 232 trout over 12 in in 1956 and 787 fish in 1958 compared to 308 in 2009. There were fewer larger fish in 2009 than either of the earlier years (Figure 23). Only 8% of the trout sampled in 2009 exceeded 16 in compared to 29% and 45% in 1956 and 1957. The primary reasons for this are the lack of older fish (Figure 24) and slower growth rate. Just one fish age V+ or older was taken in 2009. Trout in 1957 exhibited the best growth in terms of mean length at age for all three years except for age VI+ fish when

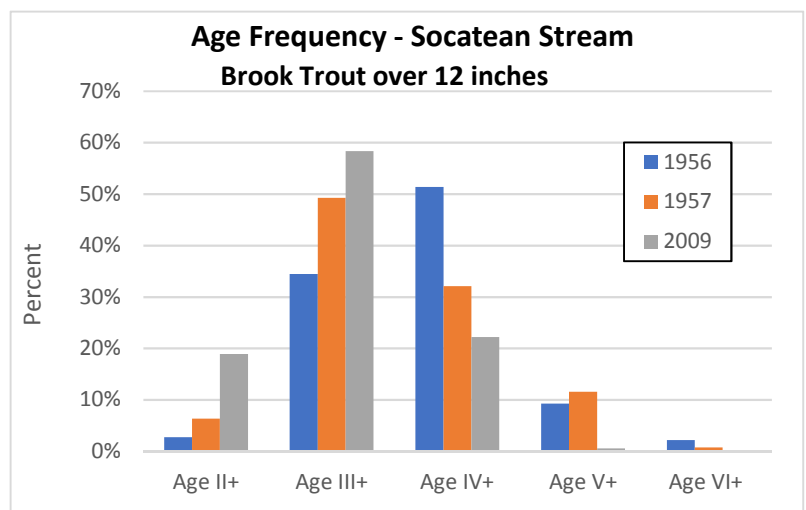
Figure 24. Brook Trout age frequency comparison from Socatean Stream.

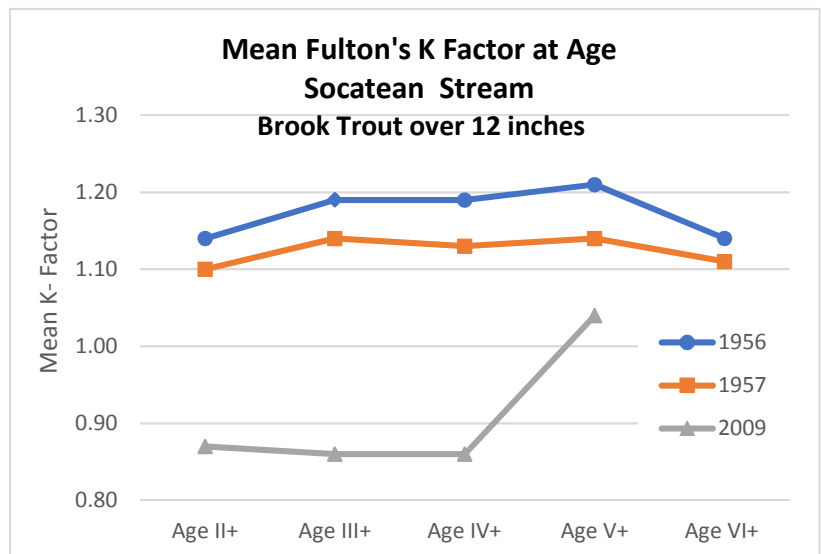
Figure 24. Brook Trout K Factor comparison from Socatean Stream.

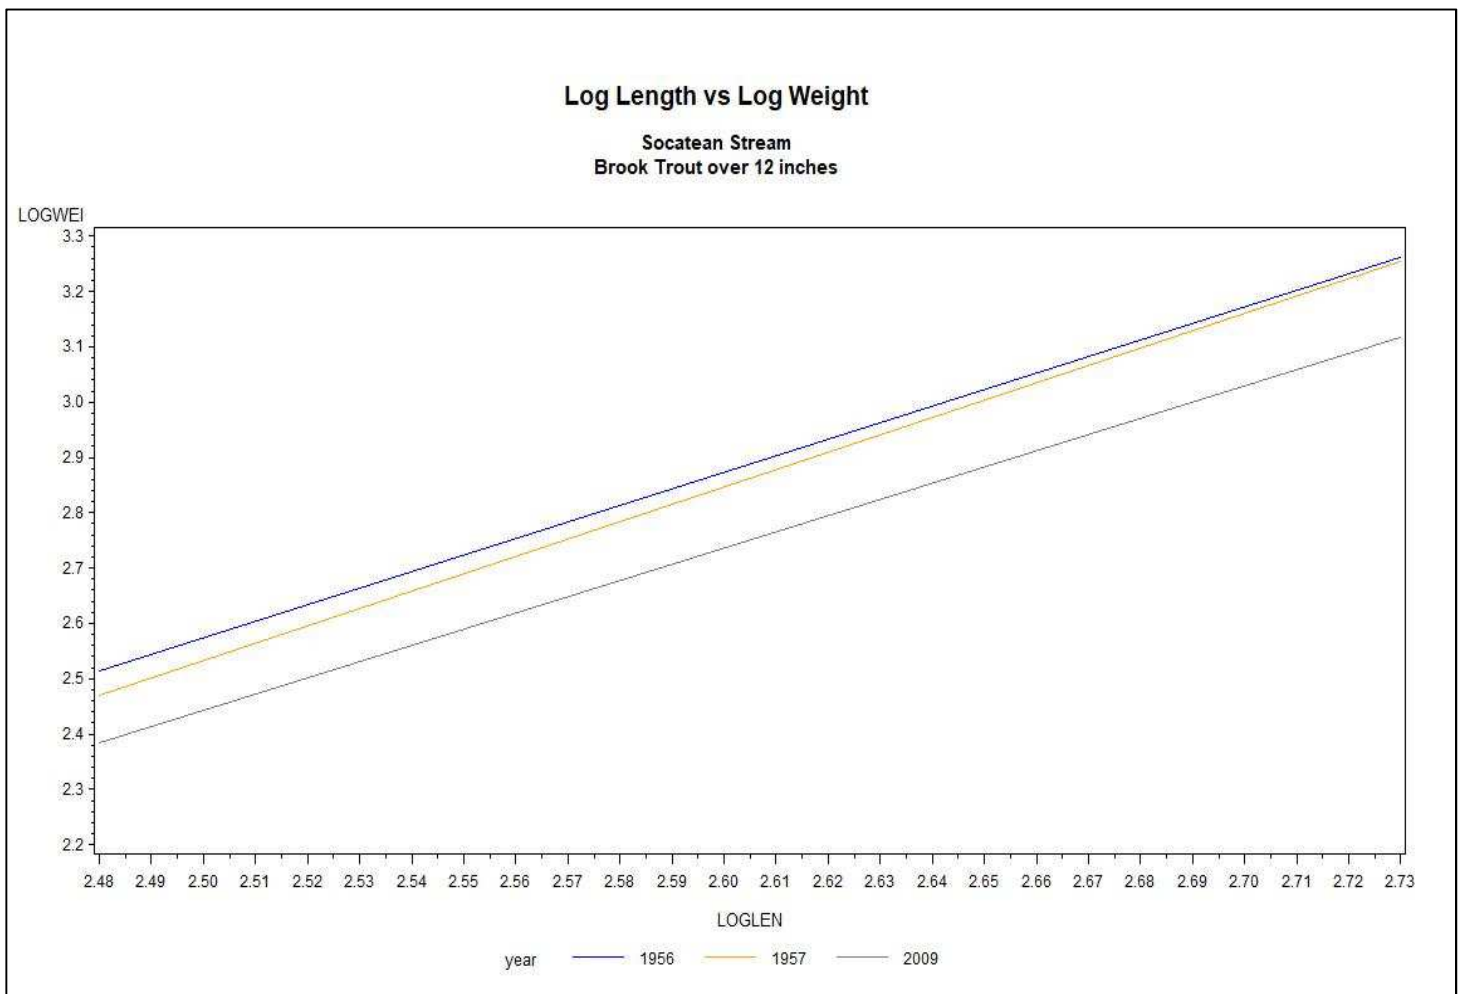
Figure 25. Analysis of covariance for the length – weight relationship for Brook Trout in Socatean Stream.

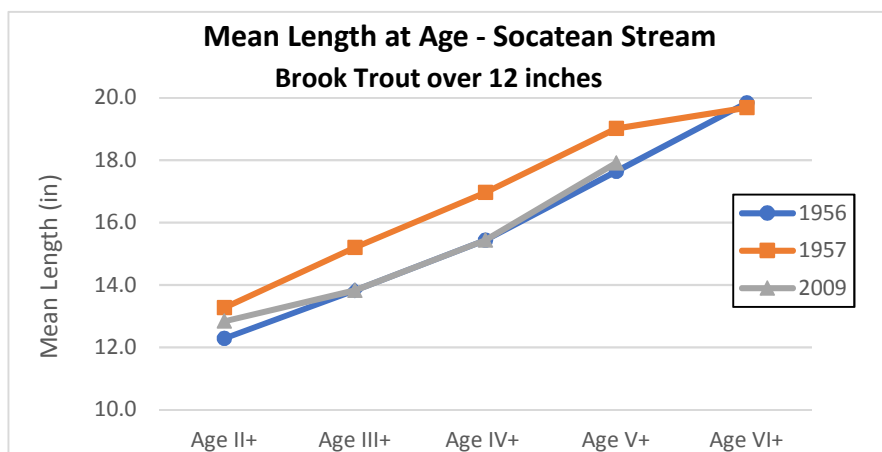
Figure 26. Brook Trout mean length at age comparison from Socatean Stream.

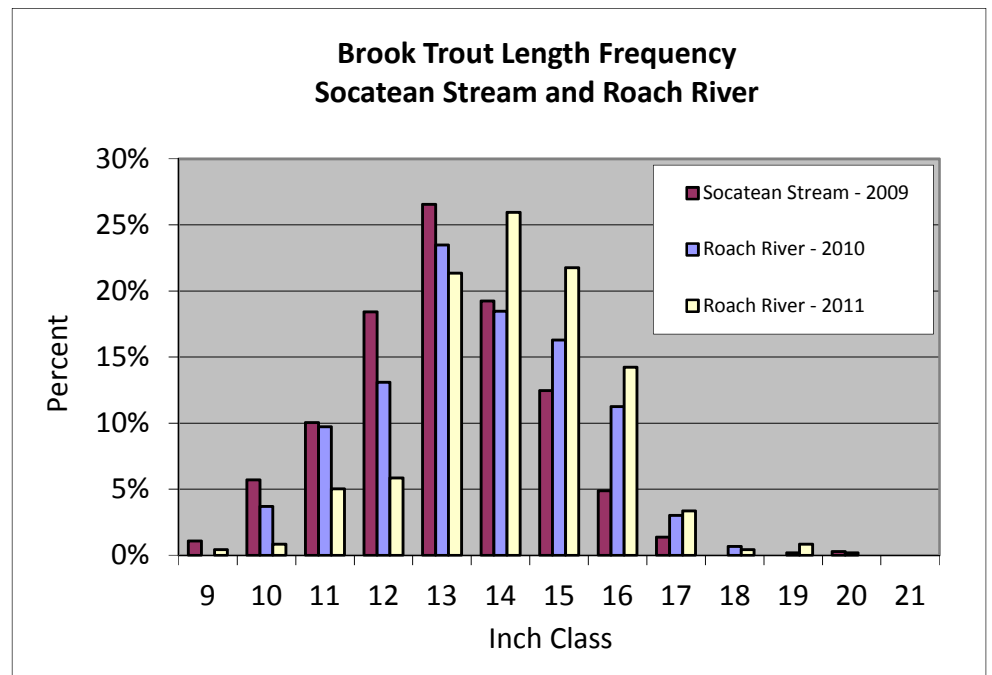
Figure 27. Comparison of Brook Trout length frequencies from Socatean Stream and the Roach River.

The lack of large trout (exceeding 18 in) in both Socatean Stream and the Roach River is noteworthy. We know these fish exist and they are observed in our winter creel surveys, reported in the Roach River voluntary box survey in September, and seen in social media reports. We anticipated capturing some larger

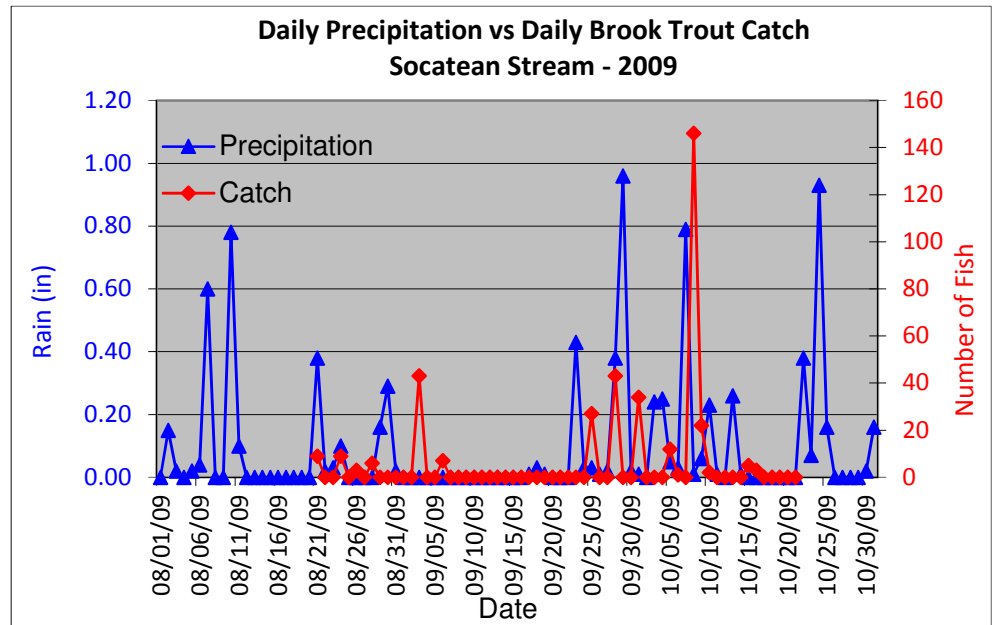
Figure 28. The relationship between precipitation (flow) and Brook Trout catch in the weir at Socatean Stream.

The catch at Socatean Stream was highly correlated with flow in the stream (Figure 29). Rain events or the removal of upstream beaver dams resulted in increased stream flow, which was followed by an increase in the catch of trout. It was interesting that the

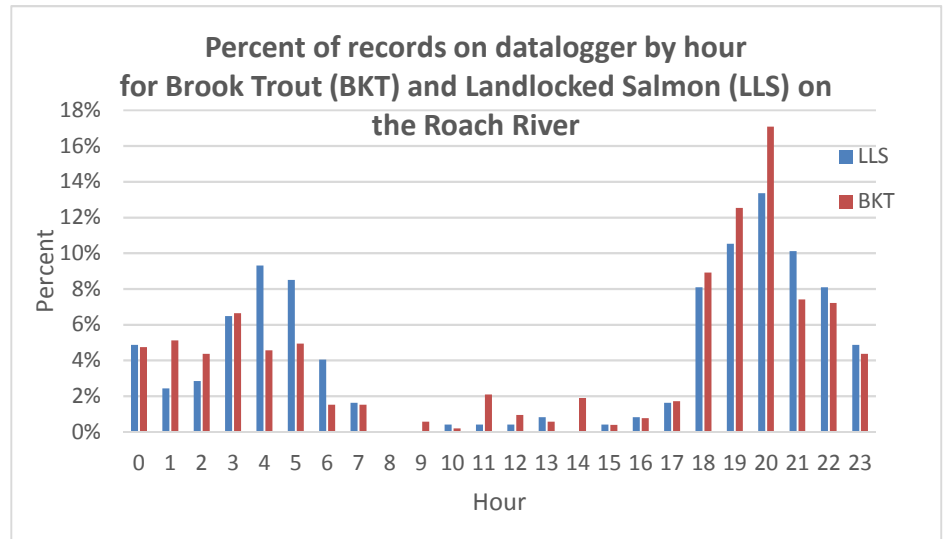
Figure 29. Time of movement for Brook Trout and Landlocked Salmon in the Roach River.

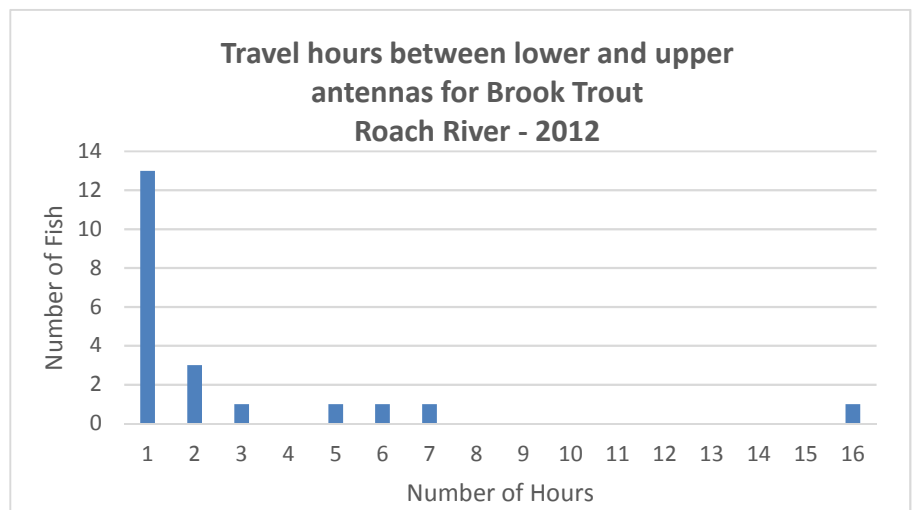
Figure 31. Travel time for Brook Trout in the Roach River.

fish moving upstream took less than two hours to make the half mile journey (Figure 31). We used radio telemetry to track the surviving post-spawning trout and evaluate the refuge areas that were established decades ago. In the winter of 2010, there were 15 active transmitters from the Socatean Stream tagging the previous fall. Two of the transmitters were still in the stream and 13 were in Moosehead Lake. Five (38%) of the ATS tagged fish in the lake were inside the protected area at the mouth of Socatean Stream and one other fish had made its way to the Spencer Bay refuge area. Seven of the tagged trout were alive in the lake in areas where they were vulnerable to ice fishing.
